Tech Note 102

Amarok Slow Pedal Return

Ref: TN102

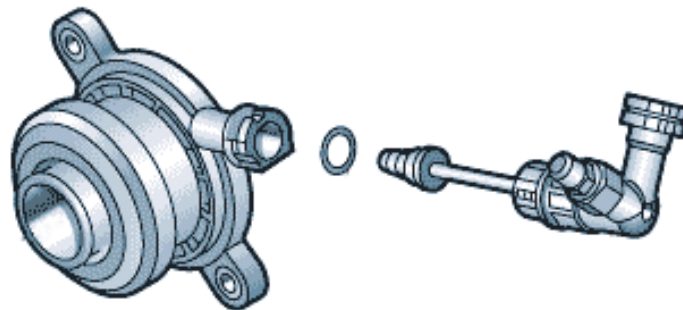
If the clutch pedal on this vehicle is slow to return or there are signs of leakage around the concentric slave cylinder, the breather assembly may require replacement.

The breather assembly connects to the inlet of the concentric slave cylinder as depicted below.

Replacement breather assemblies are available from your EXEDY distributor, quote part number HDL04.
