## Fitment instruction for CSC2382

Ref: TN059

Issue date: June 2013

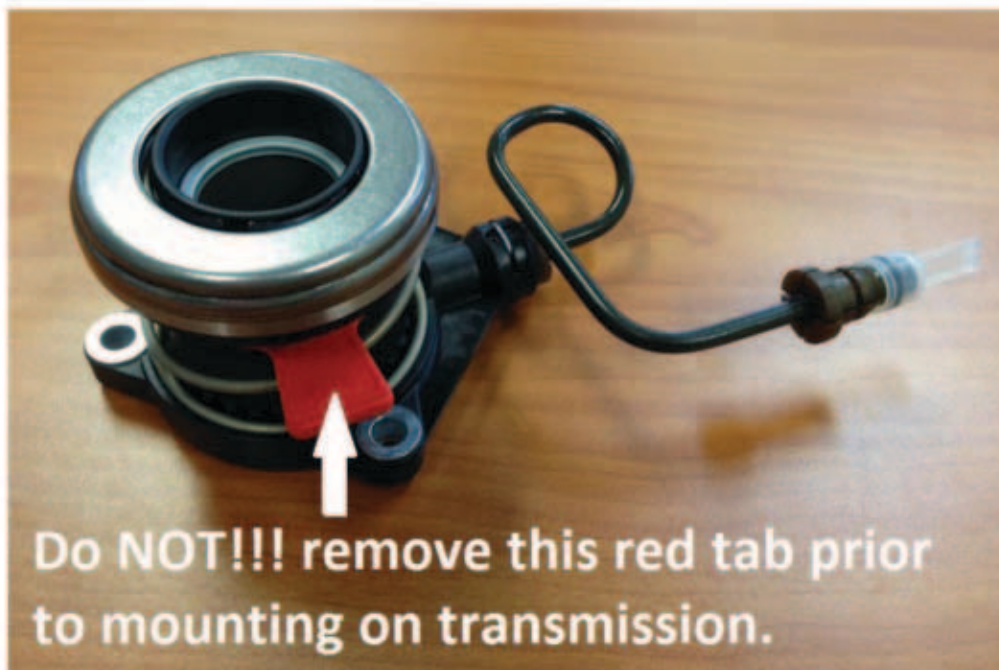
Removal of the tab prior to fitment can result in damage to the internal seal (not the separate o-ring) which causes the cylinder to leak fluid.

The red tab fitted to this Concentric Slave Cylinder should not be removed prior to mounting the cylinder to the transmission.
