# Tech Note 056

## Clutch Release Mechanism Wear / Noise

Ref: TN056

Issue Date: July 2016

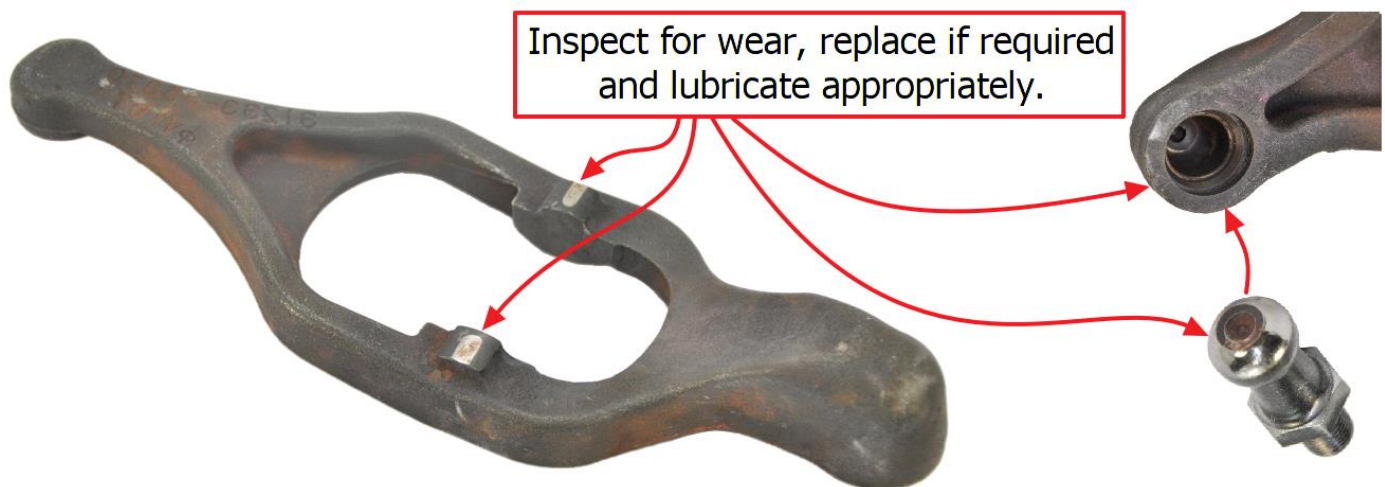
In this application, wear or inadequate lubrication of the release mechanism components often results in a noise (squeak or squeal) being emitted from within the bell-housing which is generally misdiagnosed as a release or spigot bearing fault.

It is essential clutch forks and pivot balls are cleaned, properly inspected and worn items replaced.
