Tech Note 117

UD Twin Clutch Disengagement

Ref: TN117

Issue Date: April 2021

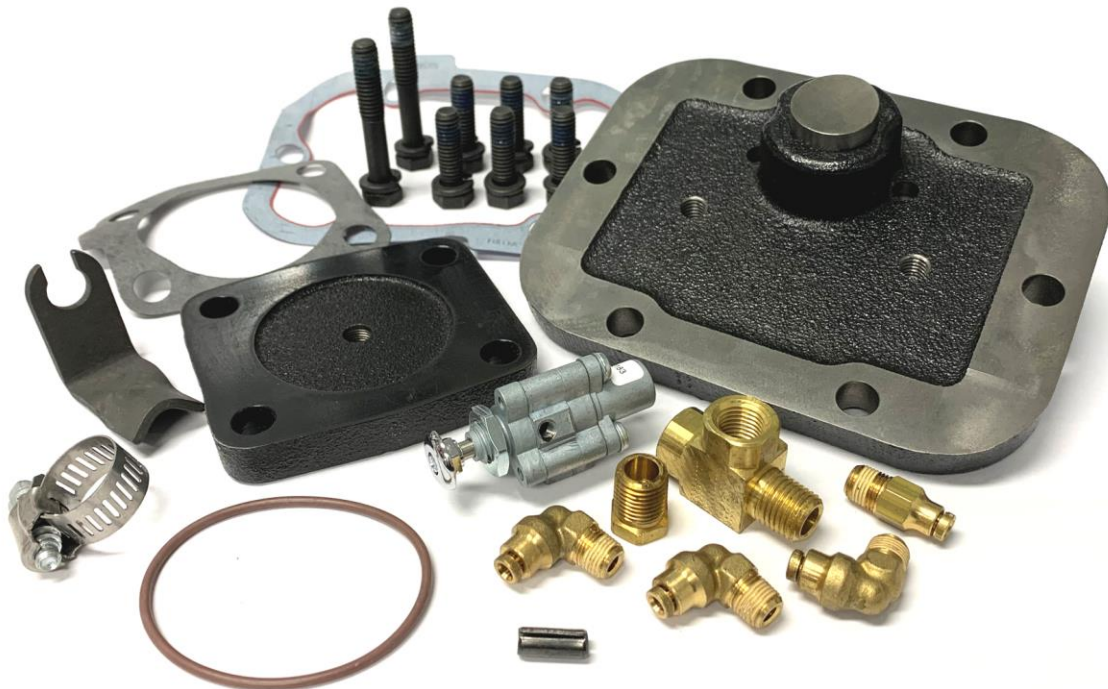
Whilst not evident prior to clutch replacement, clutch disengagement issues can commonly occur following new clutch fitment in this application. Investigations have found that these problems are often the result of excessive vehicle clutch release mechanism wear and fitment of a dedicated transmission countershaft brake kit (as per EXEDY part No. TTK-CSB pictured below) may be required where the below symptoms are being experienced.

- Difficult gear selection or disengagement
 - Creeping/Drive whilst stationary
