## Technical Information (Slave Cylinder) Holden / Isuzu

Ref: TN075

Issue date: Dec 2015

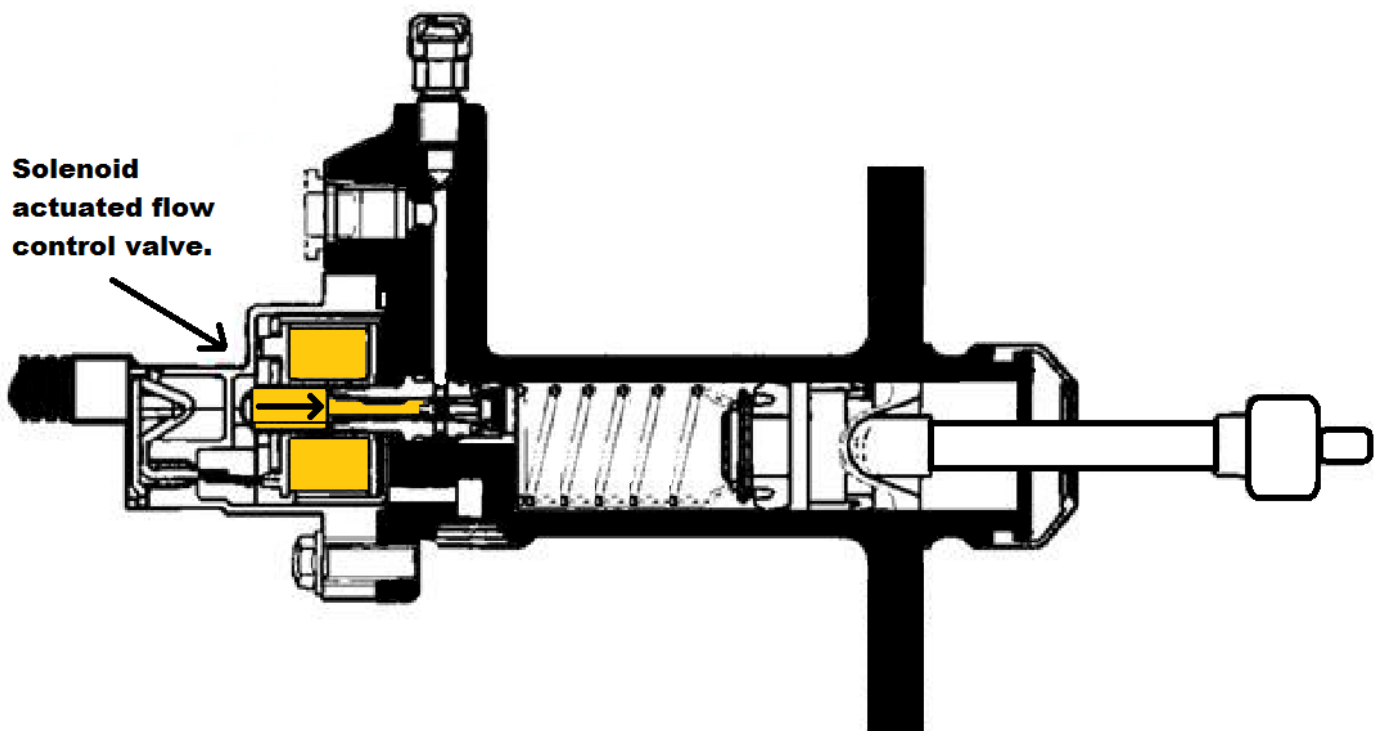
It has been found that the solenoid fitted to the rear of the clutch slave cylinder in these vehicles can often fail, therefore restricting the flow of hydraulic fluid to and from the master cylinder.

Failure to check for or replace a faulty slave cylinder may result in clutch slip, clutch non-release and premature clutch failure.

Replacement cylinders can be purchased from your EXEDY distributor, part number to order CS001.
