Tech Note H

GMH/Nissan Clutch Kits NSK-6336, NSK-6863, NSK-6921 – problem diagnosis

Issue date: 10 Dec 2004

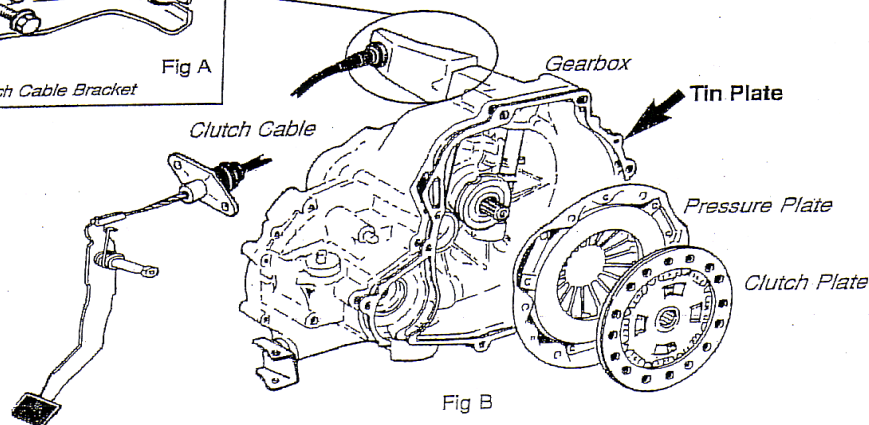
Fig A
Clutch Cable Bracket

PROBLEM: EXCESSIVE FREE TRAVEL AND CLUTCH NON RELEASE

- a) Remove clutch cable bracket (refer Fig A)
- b) Measure and drill two mounting holes approximately 5mm from existing holes towards outer edge. (1)

Holes must not be elongated (i.e. filed longer) as this may lead to eventual failure. The bracket must be drilled concentrically parallel to the original holes.

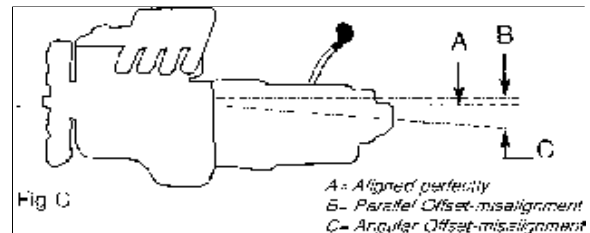
Fig C

A - Aligned perfectly
B - Parallel Offset-misalignment
C - Angular Offset-misalignment

Any misalignment will result in damage of side plate, springs and hub of the clutch disc. This will lead to total clutch failure.

The tin plate located between the motor and the gearbox surfaces (as shown below with use of arrow Fig B) must be cleaned and aligned perfectly on the dowel pins and bolts when mating gearbox to motor.
