## Mercedes Single Mass Flywheel Vibration

Ref: TN060

Issue date: 27 July 2013

Issue number: 1

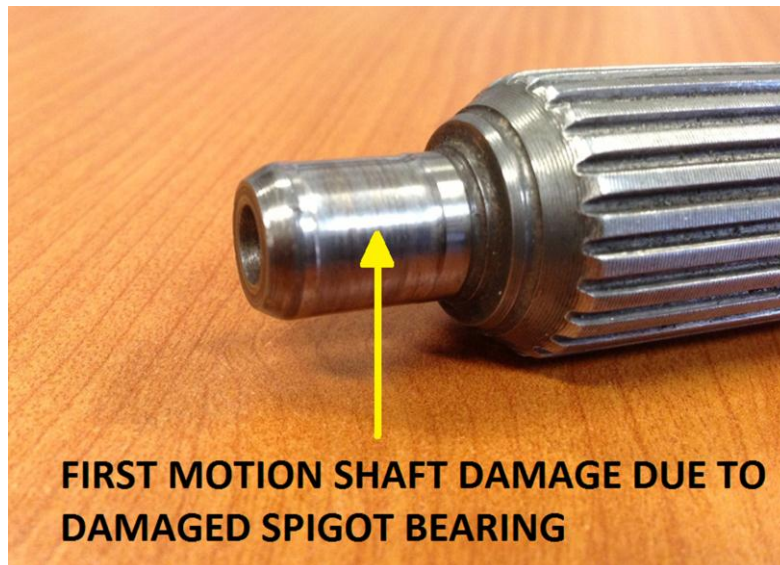
- As with any clutch being installed it is crucial that the transmission is supported correctly during this installation. Failure to do so can & has resulted in damage to the spigot bearing and therefore eccentric rotation of the first motion shaft. This eccentric rotation of the first motion shaft will then produce vibrations through the driveline & increase the wear rate of components within the transmission.
