Poor Clutch Release Holden Rodeo 2.8Ltr

Diesel Turbo

Ref: TN016

Issue date: 30 May 2005

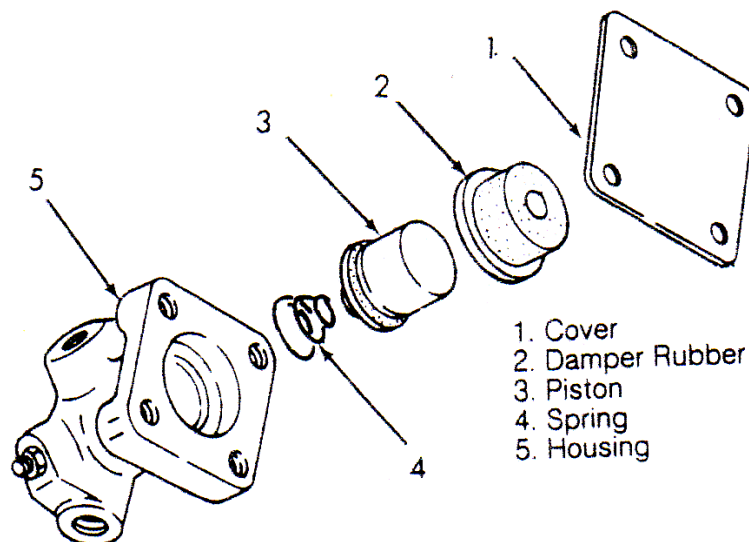
These vehicles are fitted with a Clutch Damper similar to that illustrated between the Clutch Master Cylinder and the Slave Cylinder.

It has been found that the Clutch Damper has been the cause of the problem, with the cup bypassing fluid and/or the Damper Rubber compressing, which in turn restricts the fluid flow necessary to obtain the required slave cylinder travel.

Should you experience the subject concern, if you find you are able to lever the fork a little further, and the clutch releases correctly then the concern is likely to be the Clutch Damper.

To test if the Clutch Damper is at fault, make an hydraulic line to bypass the Damper, or use a suitable size joiner, if the clutch then operates correctly, the Clutch Damper should be replaced. It has been found replacement of the cup only in the Damper has not rectified the concern.

EXEDY Australia recommends that it is important the Damper is replaced and not substituted by the hydraulic bypass line or joiner.
