Tech Note 102

Amarok Slow Pedal Return

Ref: TN102

Issue Number: 2

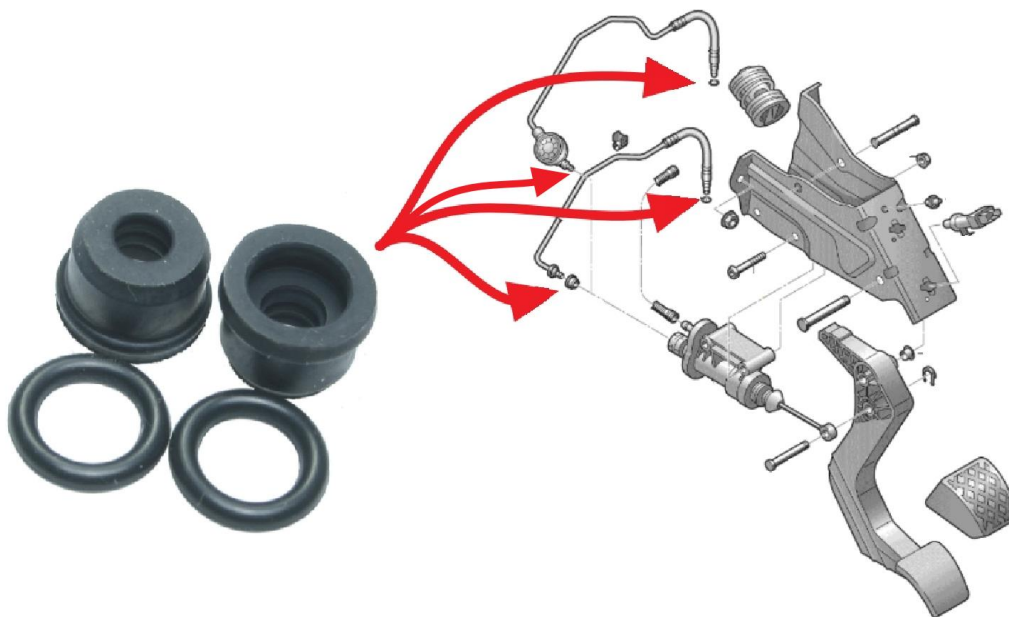
Issues relating to slow pedal return are commonly the result of perished seals within the clutch hydraulic delivery line. To avoid slow pedal return issues, it is highly recommended the replacement seal kit (EXEDY Part No. SEAL03) supplied as part of this clutch kit be fitted upon clutch installation. Please refer to below image for location of seals along the respective type of hydraulic delivery line.

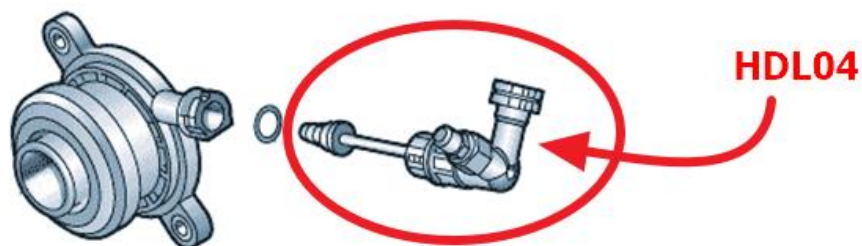
The breather assembly connecting the hydraulic delivery line to the concentric slave cylinder (as depicted below) may also contribute to the above-mentioned concern. Replacement breather assemblies are available from your EXEDY distributor, quote part number HDL04.
