Holden Cruze Hydraulic Failure

Ref: TN107

Issue Date: Oct 2019

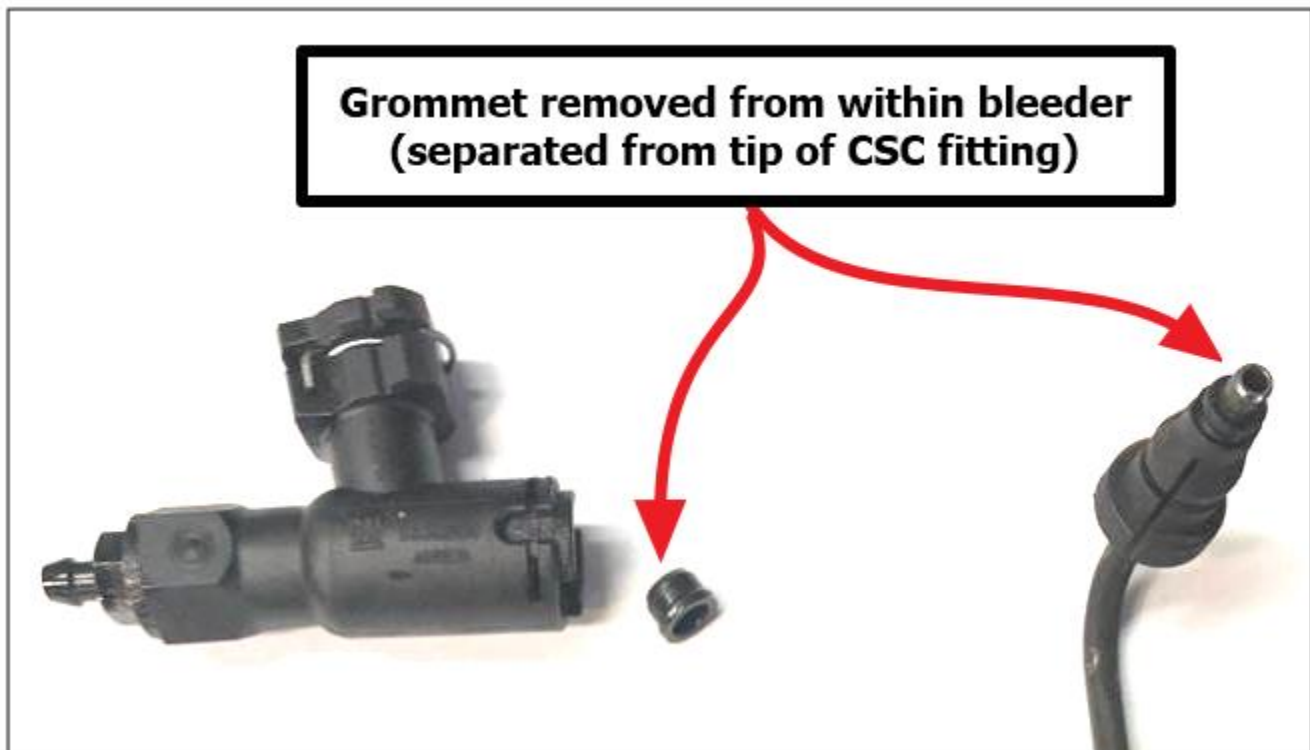
The rubber grommet (pictured below) may detach from the original concentric slave cylinder (CSC) whilst being disconnected from the bleeder fitting in this application.

Failure to identify and remove the grommet prior to fitment of the replacement cylinder will often result in complete hydraulic failure due to over-pressurisation of the CSC.
