VN Commodore Fork Rattle

Ref: TNF

Issue date: 10 Dec 2004

Issue number: 2

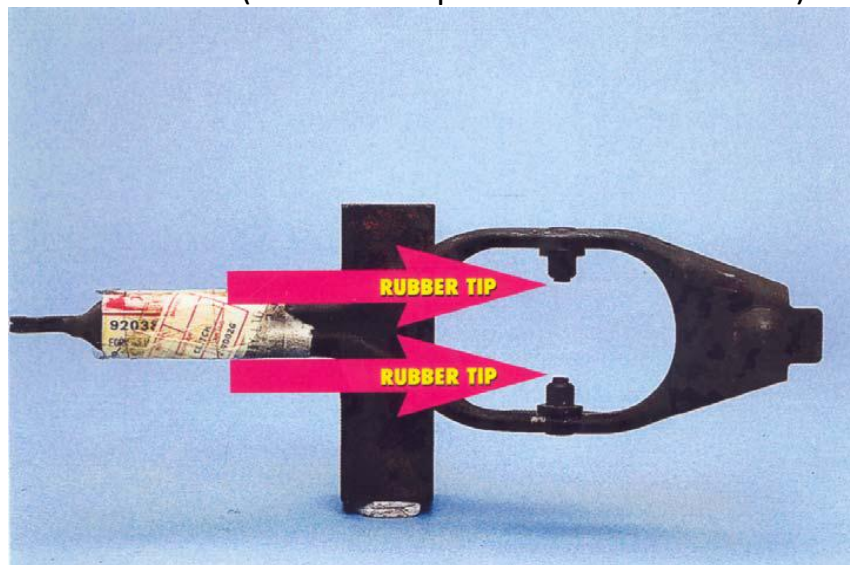
It has been brought to our attention that after a new clutch kit has been fitted that contains bearing part number BRG 2204 or BRG 2110, a rattle from the bearing and clutch fork area is apparent.

The design of the fork and the window of the bell-housing where the fork protrudes cause the fork to drop and rattle against the window of the bell-housing when the fork absorber rubbers are worn.

Check clutch fork rubber absorber bushes as per the diagram and in the event that these bushes are worn, they must be replaced.

NOTE: Bearing must be a tight fit

Replacement absorber rubbers x 2 (GM-Holden part number # 3994273) are required.
