Ford Ranger & Explorer Clutch Non Release

Ref: TN029

Issue date: 28 May 2008

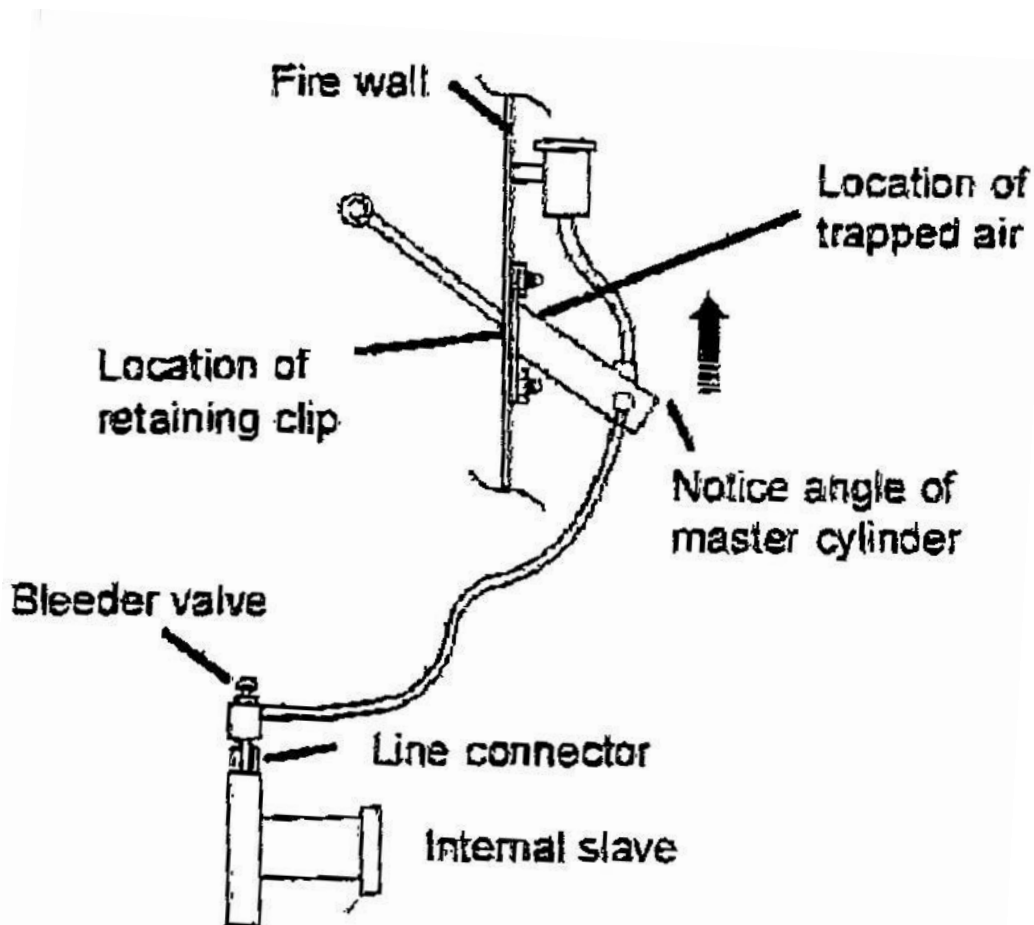
Air trapped in the hydraulic release system.

As a result of the clutch master cylinder location on the firewall, air can remain trapped in the cylinder.

It is recommended the master cylinder be pre-bled prior to installation in the vehicle. It has been reported that successful bleeding can be achieved by raising the front of the vehicle to an angle that allows the air to escape to the delivery line end of the cylinder.
