Important Information

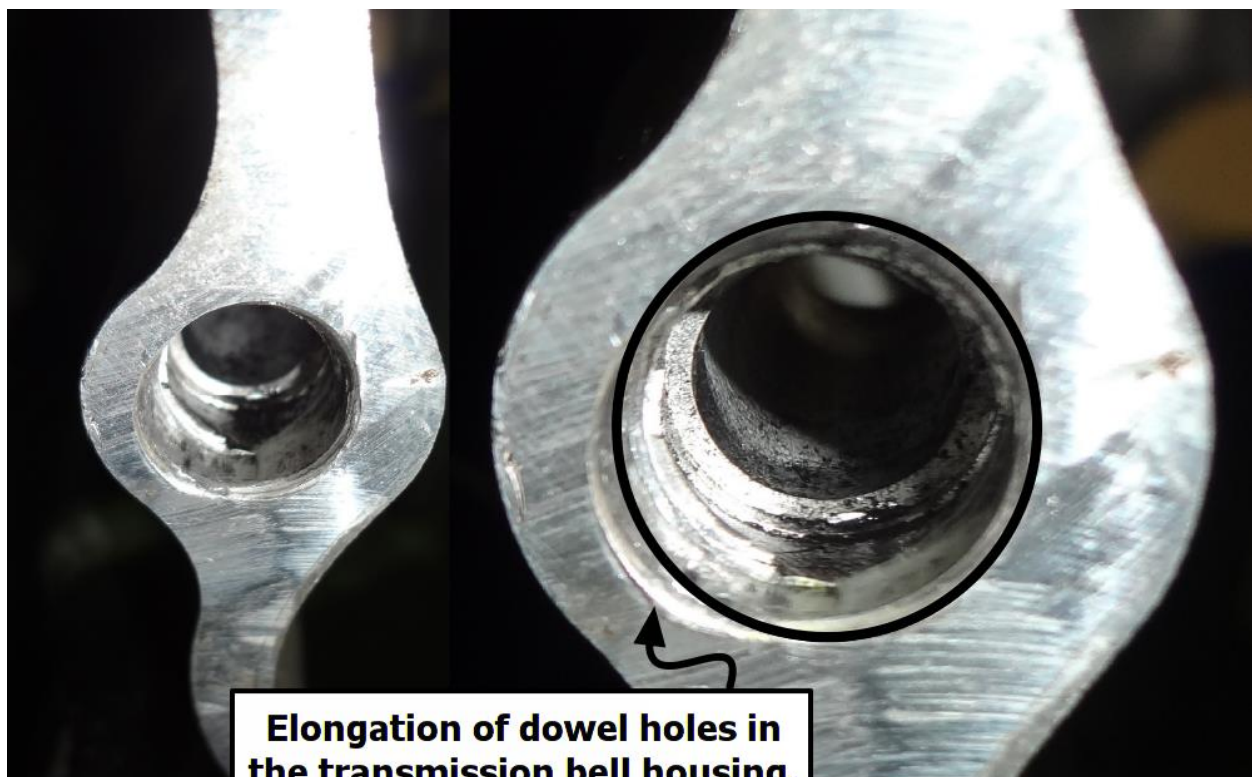
Severe elongation of the bell housing locating dowel holes is a known concern in this application.

Driveline misalignment caused by this concern and the resultant harmonic vibration through the transmission may result in disengagement of gear whilst driving (commonly 5th) and a significantly reduced clutch service life.
