Audi, Seat, Skoda, VW - Avoid Clutch Pedal Vibrations from MY03 on

Ref: TN048

Issue date: 25 May 2011

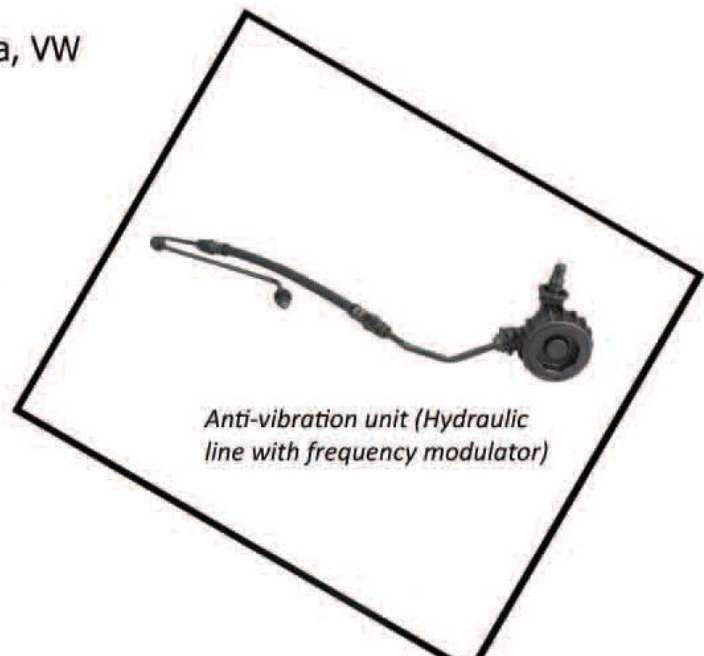
OE No. 1K1 721 564 AP

The frequency modulator suppresses pulsations in the system's hydraulic fluid, thereby preventing vibrations at the clutch pedal. In many cases, this error is incorrectly attributed to a faulty clutch or to the dual mass flywheel.

If necessary, the hydraulic line with frequency modulator should be replaced and subsequently refitted. Contact the vehicle manufacturer for the relevant parts.
