# Tech Note 051

## Correct Grease Application

Ref: TN051

Issue Date: Aug 2023

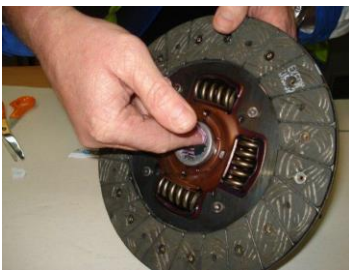
#### Step 1

A tube of high melting point grease is supplied with every EXEDY clutch kit. Open the tube and apply a small amount of grease to the splined hub of the clutch driven disc.

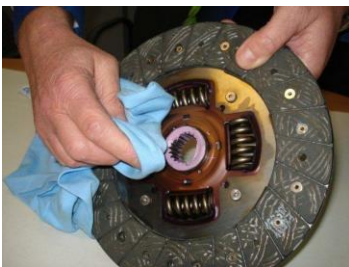
#### Step 3

Remove the disc from the input shaft and remove any excess grease from the splined hub and input shaft.

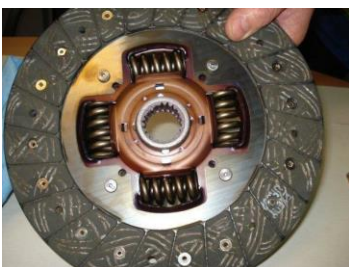
#### Step 4

Be careful not to contaminate the friction material as this may result in clutch shudder and /or slip. Ensure that your hands are clean, or you are wearing clean gloves.
