Correct Fitment of Release Bearing Retainer Clips In Various Nissan, Holden & Ford Applications

Ref: TNS

Issue date: 24 Sep 2013

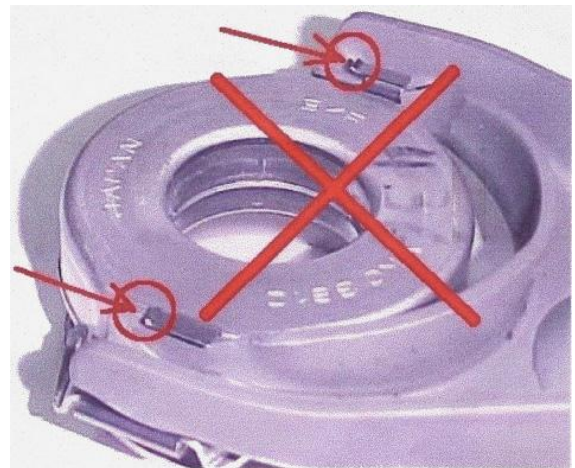
Should the release bearing be fitted incorrectly in this application, it is possible you may experience bad shudder and / or fork vibration; the latter may be severe enough to cause entire vehicle to shake and vibrate.

UPSWEPT SECTION OF CLIPS FACING AWAY FROM FORK. THIS IS.....

INCORRECT !!

To minimize this occurrence, the release bearing must be fitted with the upswept section of the bearing retainer clips facing towards the fork. If retainer clips are not orientated correctly, symptoms described above may be experienced.

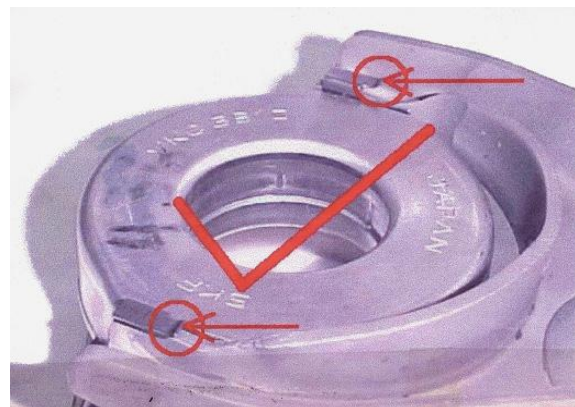
UPSWEPT SECTION OF CLIPS FACING TOWARDS FORK. THIS IS.....

CORRECT!!
