# 215mm Mazda Rotary Clutch Cover Installation

Ref: TN103

Issue Date: Dec 2017

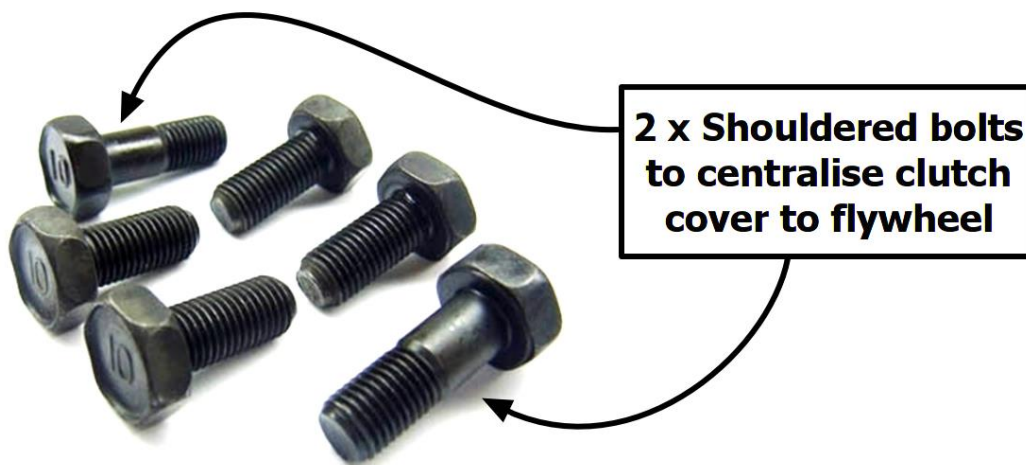
In this application, two of the six clutch cover bolts (as pictured below) are shouldered and must be used to correctly centralise the clutch cover to the flywheel.

Failure to use correct bolts or correctly secure the clutch cover to the flywheel may result in serious personal injury or damage to property.
