# Tech Note 041

## Transportation Clips

Ref: TN041

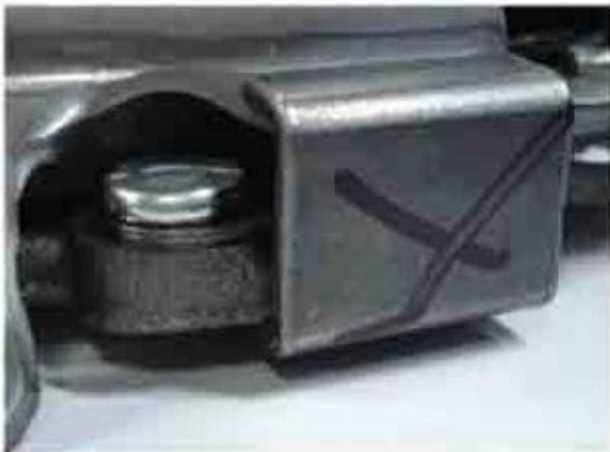
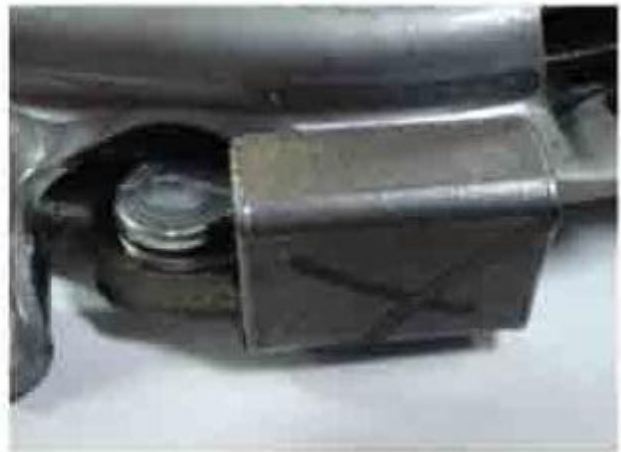
This kit may contain a cover assembly that has clips securing the pressure plate to the cover pressing during transport.

Failure to remove the clips will result in major damage to the bell housing.

It is imperative that these clips (three off) be removed prior to the assembly being bolted to the flywheel. Technique-Depress the diaphragm fingers under a drill press to release the clips.
